Manhole Inspection Summary

Manhole # S490__002MH

Insp Date: **9/3/08 12:30 PM**

Location Address: **2701 light house point**

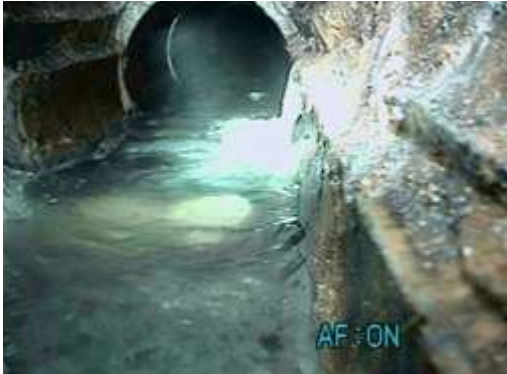
misc

channel debris

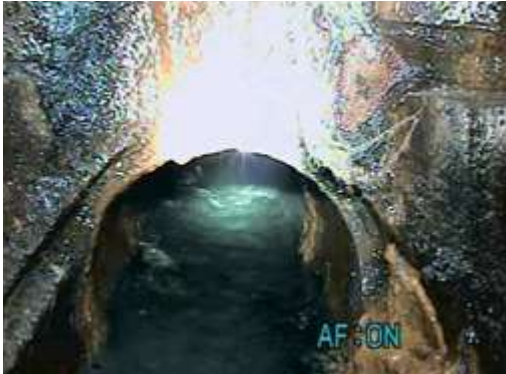
Defect 2

Infiltration: ☐ None ☐ Joint ☐ Cracks ☐ Mortar ☐ Roots ☒ **Wall**

Barrel Infiltration

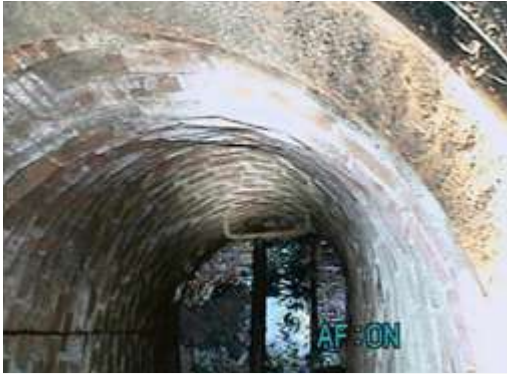
Defect 1

Count: **1** Missing: **0** ☒ **Corroded**

step

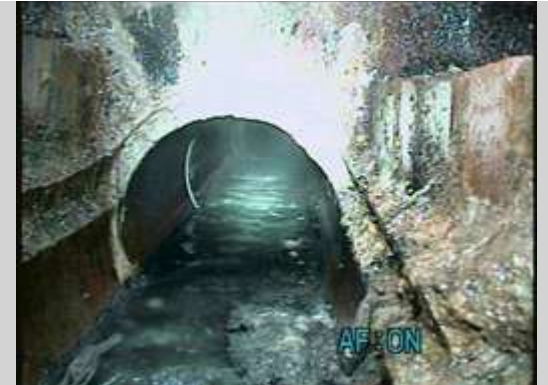
12 O'Clock Outflow

10 in. Circular Gravity Sewer
Pipe Out @ 12 O'Clock

Pipe Material: **Clay** ☐ Pipe Lined

Invert Depth: **9.75** (ft.) Flow Characteristics: **Fast**

Infiltration: **None** Pipe Seal Cond: **Unknown**

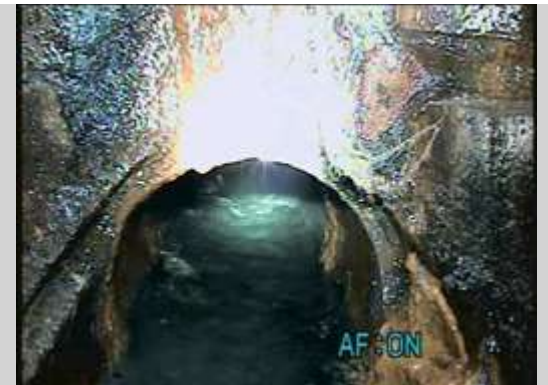
6 O'Clock Inflow

10 in. Circular Gravity Sewer
Pipe In @ 6 O'Clock

Pipe Material: **Clay** ☐ Pipe Lined

Invert Depth: **9.60** (ft.) Flow Characteristics: **Fast**

Infiltration: **None** Pipe Seal Cond: **Unknown**

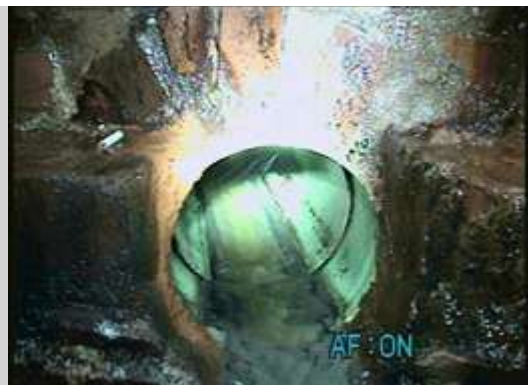
9 O'Clock Inflow

8 in. Circular Gravity Sewer
Pipe In @ 9 O'Clock

Pipe Material: **PVC** ☐ Pipe Lined

Invert Depth: **9.50** (ft.) Flow Characteristics: **Fast**

Infiltration: **None** Pipe Seal Cond: **Unknown**
